Erasing SATA drives in caddies with interposers/adapters

| Created date | Updated date | Affects version | Fix version |
|---|---|---|---|
| 12 Feb 2020 | 25 Feb 2020 | Drive Eraser - all versions | N/A |

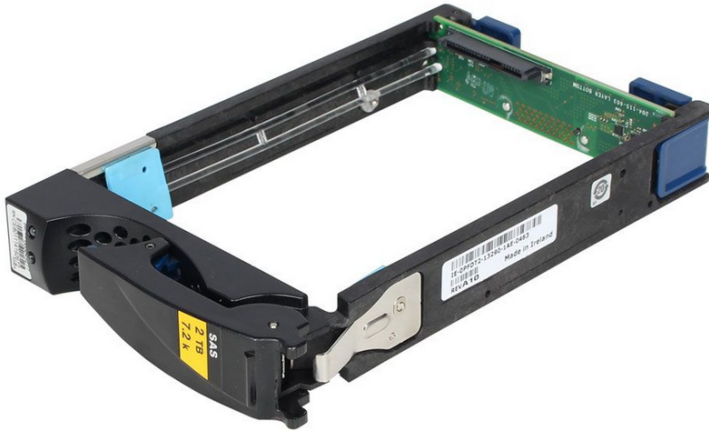
SATA drives in caddies with adapters/interposers failing to erase. This issue is seen with the EMC VMAX as well as other similar hardware where the native drive is SATA and the drive is connected to a fiber channel interposer or an adapter.

Below picture shows a drive caddy with SATA to Fiber Channel adapter.

In some storage systems, native SATA drives can sometimes be connected using a interposers or bridged adapters which change the physical interface and the location of the physical port. One of the most common adapter causing this issue is SATA to Fiber Channel interposers/adapters.

We have seen particular issues with EMC VMAX systems that are using Fibre Channel arrays, but the parent drive is native SATA drive connected using a FC adapter. Native Fibre Channel and SAS drives will erase successfully due to similar set of standards versus SATA requiring ATA commands.

In order to prevent any issues caused the by interposers/adapters it is recommended to remove any adapters before running the erasure using Blancco Drive Eraser. After disconnecting the drives from the adapter, they can be erased externally in different array or Blancco Hardware Appliance using native drive interface (SATA).

Alternatively, [Blancco LUN Eraser](#) could be used to run an erasure on the logical volumes.
